LESSONS LEARNED FOR PRESENTATION TO SEAFARERS (FSI 20)

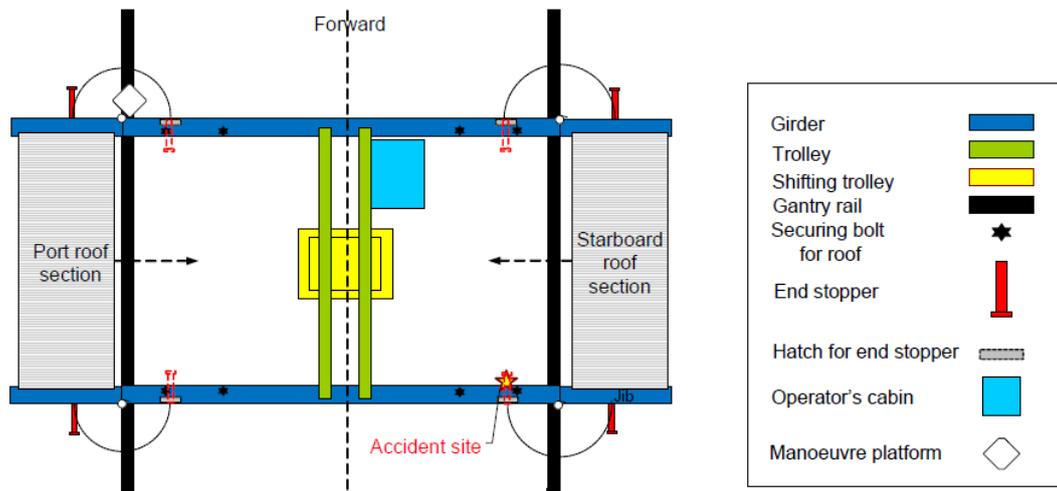
After confirmation that all crew were in a safe position, the four jibs were set in motion. Subsequently, and without notifying the other crew involved, two crew members on the girdens of the gantry crane identified that the end stopper hatches located in the protective walls needed to be open. The two crew then immediately went and opened the end stopper hatches. Following that, one crewmember was found struck and killed by the end stop of the starboard aft jib.

Figure 1: Simplified drawing of the gantry crane seen from above.

After having opened the hatch for the end stop, he may have given his attention to checking the chain to be attached to the T-shaped securing bolt in the aft corner of the starboard sliding roof section. This is based on where the boatswain was hit and the position in which he was found.
